IRB HULL - INSPECTION CHECKLIST	Acceptable	Unacceptable
IRB Code of Conduct (on Notice Board)		
Floorboards Out

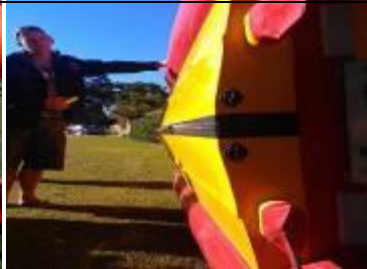
<p data-bbox="636 517 1001 786">Resin painted slightly over hypalon</p>

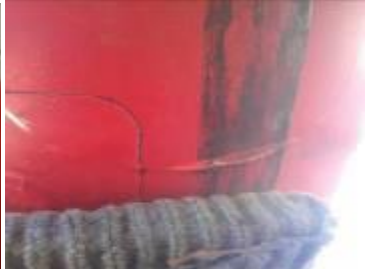
<p data-bbox="636 823 1001 1093">Wear strip lifted – not a safety issue</p>

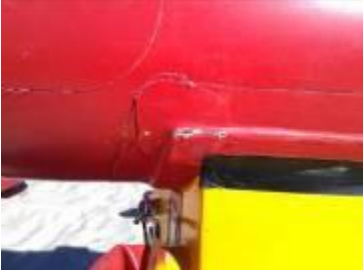
<p data-bbox="275 1129 636 1399">Minor wear but not to base material:</p>

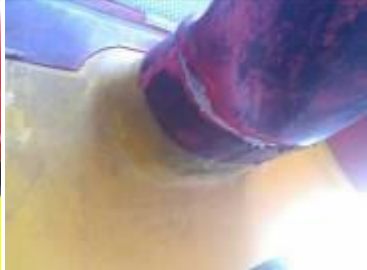
<p data-bbox="636 1129 1001 1399">Likewise on self bailer – will last the season</p>

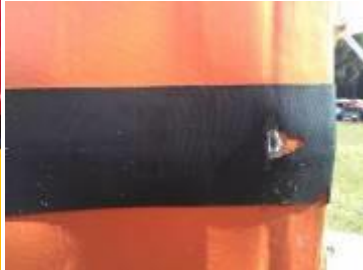
<p data-bbox="1767 671 2128 941">Wear through to base layer</p>

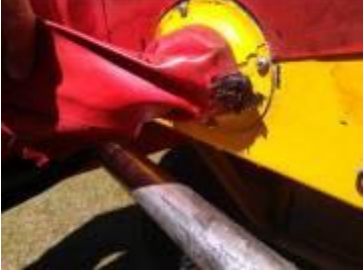
<p data-bbox="1406 978 1767 1248">Rib self bailer damaged and will let water into hull:</p>

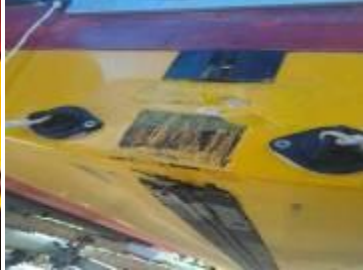
<p data-bbox="1767 978 2128 1248">Wear strip missing</p>

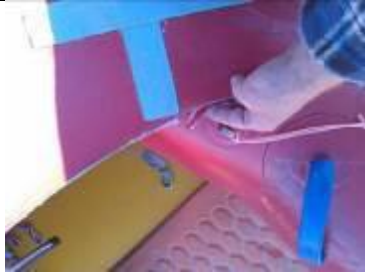
<p data-bbox="1402 478 2072 507">Spray dodger at crew position, worn and may tear under heavy impact</p>
Bow Rope + Handle

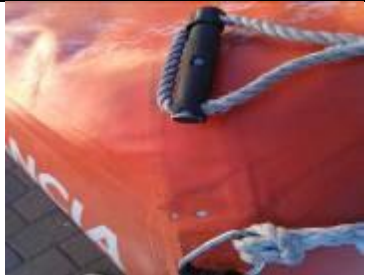
<p data-bbox="1402 782 1915 810">Crew handle is sharp on the end (protector is missing)</p>
Bow Rope D Fitting		
Pontoon Ropes on Sides (Life lines)

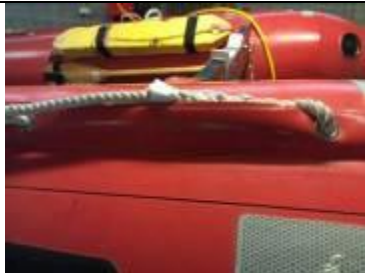
<p data-bbox="1402 1161 1590 1190">Life line is too tight:</p> <p data-bbox="1769 1161 2132 1190">Eyelet has lifted – potential cut hazard</p>

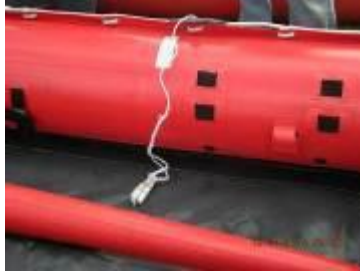
<p>No Velcro straps</p>
Whistle

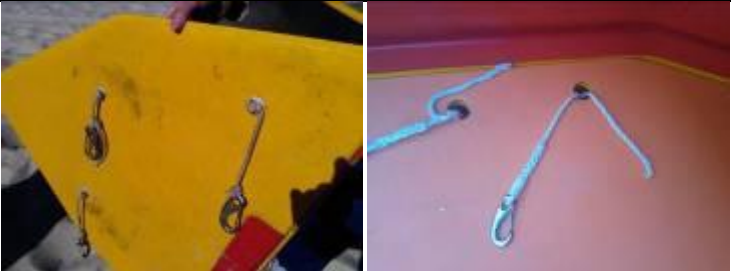
<p>Clip is tied in, not spliced: No knot to secure the clip</p>

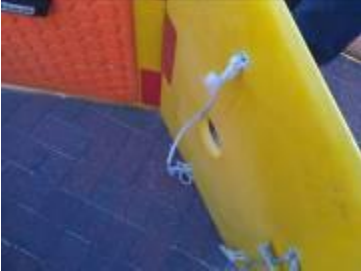
<p>Series of Murrumbidgee Frog knots that will eventually untie and is unreliable</p>

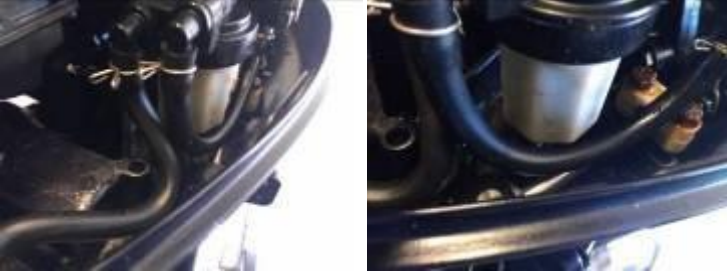
<p data-bbox="1406 1410 2130 1436">Fuel line from filter to pump is too long and is rubbed by the throttle link rod.</p>
