IRB HULL - INSPECTION CHECKLIST	Acceptable	Unacceptable
IRB Code of Conduct (on Notice Board)		
Floorboards Out

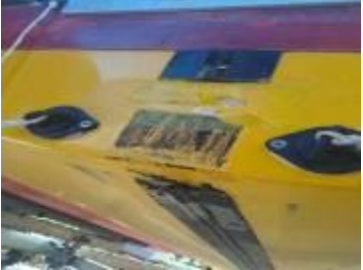
<p>Wear through to base layer</p>

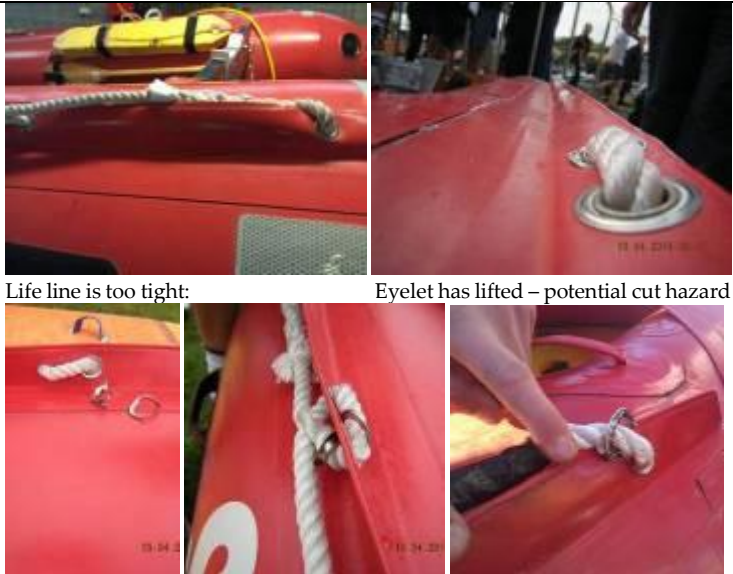
<p data-bbox="1402 1161 1590 1190">Life line is too tight:</p> <p data-bbox="1769 1161 2132 1190">Eyelet has lifted – potential cut hazard</p> <p data-bbox="1402 1460 1892 1489">Eyelet is broken – cut hazard (see above and below)</p>

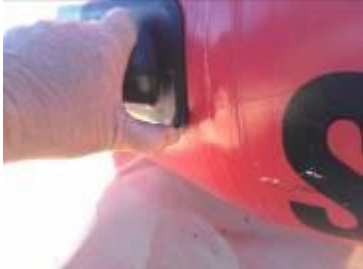
<p data-bbox="1404 743 1908 767">Handle is lifting (pun intended) - needs to be repaired</p>
Driver's Boarding Handle

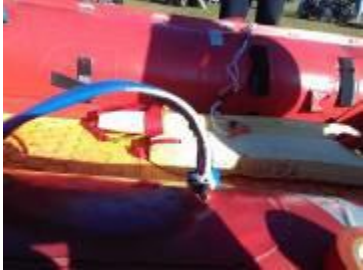
<p data-bbox="1404 1046 1697 1070">Worn handle – abrasion hazard</p>
Crewperson's Boarding Handle

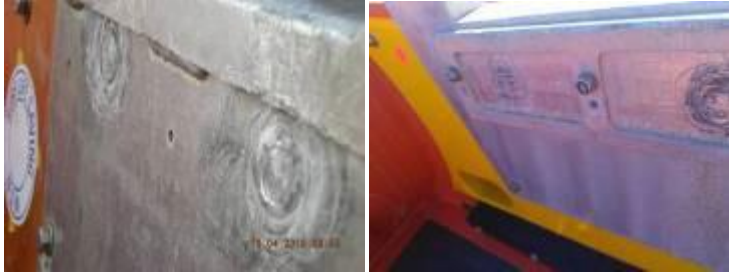
<p data-bbox="999 472 1290 496">Bolts are cut flush with the nut</p>	  <p data-bbox="1404 483 2134 507">OK if the bolt is behind the motor, but fails if exposed (eg. side of the transom)</p>
Transom Lip (3mm Square)

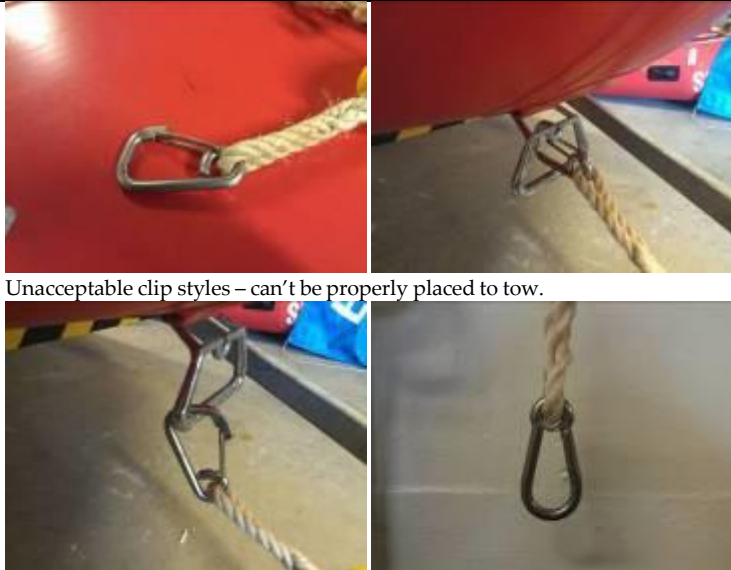
<p>Unacceptable clip styles – can't be properly placed to tow.</p> <p>Incorrect fitting will twist the tow handle: Unacceptable clip – cut hazard</p>
Approved Rescue Tube: Stowage

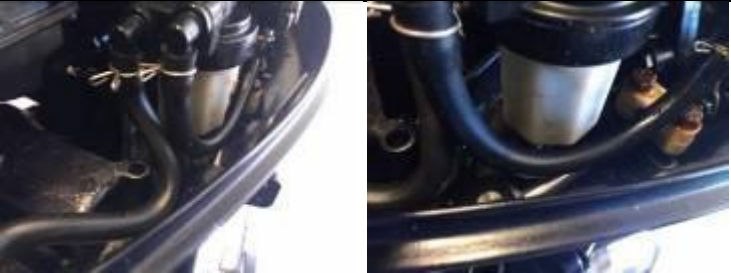
<p data-bbox="1406 1414 2134 1437">Fuel line from filter to pump is too long and is rubbed by the throttle link rod.</p>

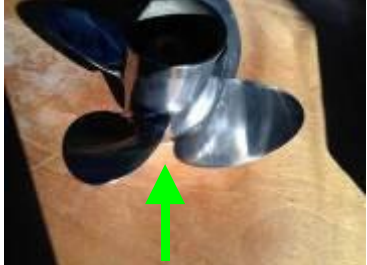
<p data-bbox="1402 1150 1861 1174">Ballistic shape (not 'out of the box' nor standard)</p>
Propeller Guard		
Prop Guard Securely Fixed		
Prop Guard Serial No. (if present)
