IRB HULL - INSPECTION CHECKLIST	Acceptable	Unacceptable
IRB Code of Conduct (on Notice Board)		
Floorboards Out

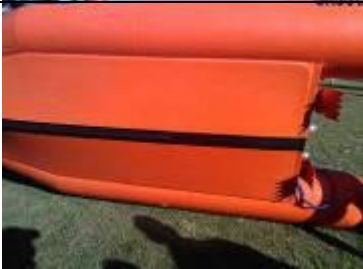
Pontoon Wear to Underside	<p data-bbox="275 798 504 821">Good general condition:</p>

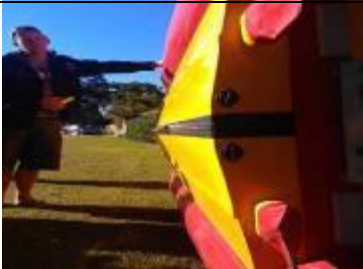
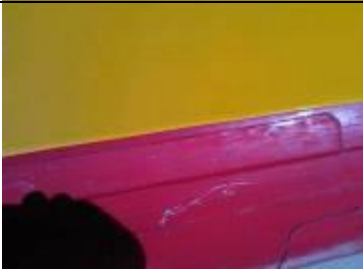
<p data-bbox="1003 798 1339 821">Resin painted slightly over hypalon</p>

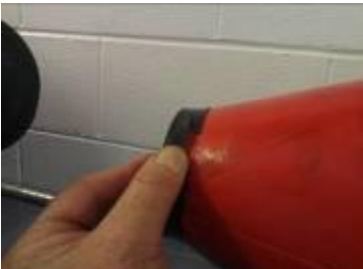
<p data-bbox="275 1101 571 1125">End cap torn, not a safety issue:</p>

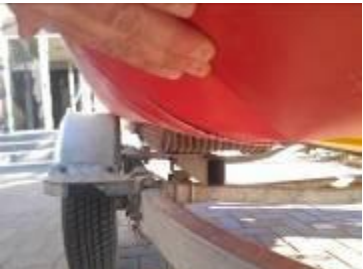
<p data-bbox="645 1101 981 1125">Wear strip lifted – not a safety issue</p>

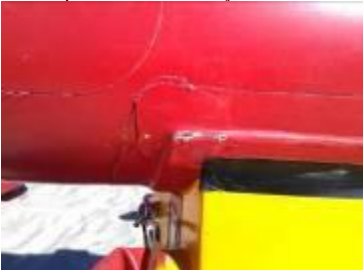
<p data-bbox="275 1404 616 1428">Minor wear but not to base material:</p>

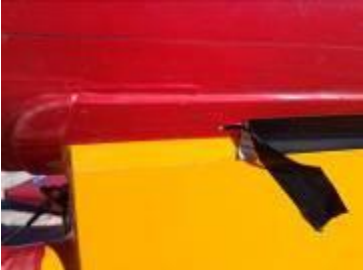
<p data-bbox="645 1404 1041 1428">Likewise on self bailer – will last the season</p>

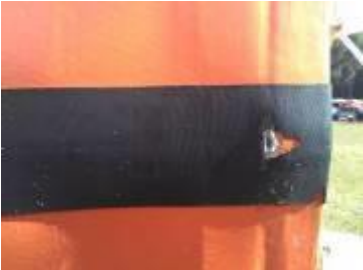
<p data-bbox="1406 949 1736 973">Underside sanded but not resin-ed:</p>

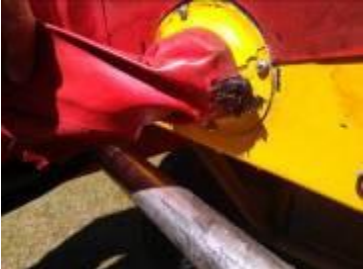
<p data-bbox="1771 949 2027 973">Wear through to base layer</p>

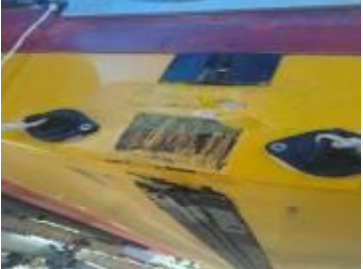
<p data-bbox="1406 1252 2060 1276">Rib self bailer damaged and will let water into hull: Wear strip missing</p>

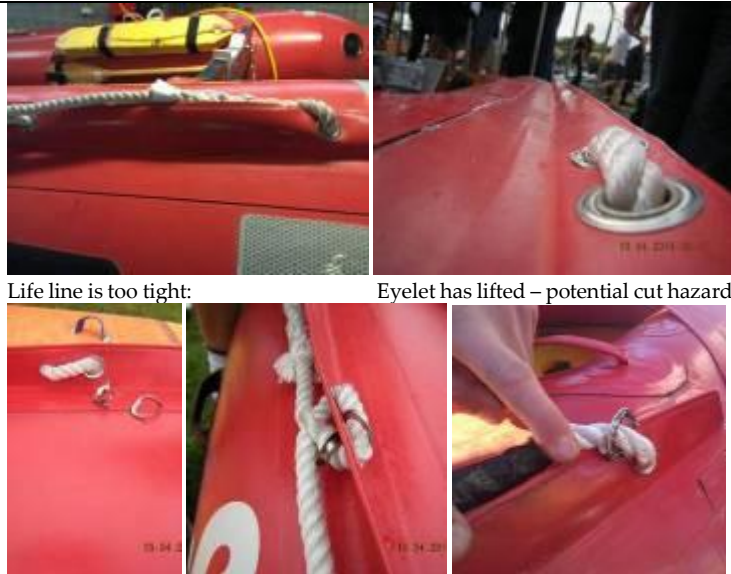
<p data-bbox="273 1372 1317 1487">Sufficient slack (but not too much): Eye lets in good condition, not lifted and not sharp or corroded</p>

<p data-bbox="1400 1161 1765 1189">Life line is too tight:</p> <p data-bbox="1765 1161 2128 1189">Eyelet has lifted – potential cut hazard</p> <p data-bbox="1400 1460 2128 1487">Eyelet is broken – cut hazard (see above and below)</p>

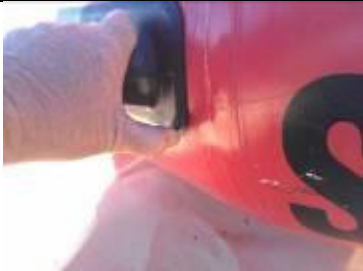
<p data-bbox="1404 742 1908 770">Handle is lifting (pun intended) - needs to be repaired</p>
Driver's Boarding Handle

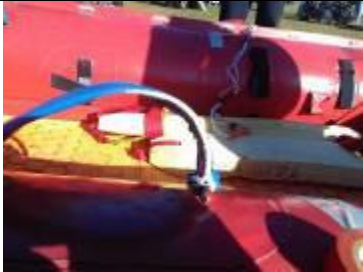
<p data-bbox="1404 1045 1697 1074">Worn handle – abrasion hazard</p>
Crewperson's Boarding Handle

<p data-bbox="273 1045 600 1074">Ok to tape as a temporary measure</p>

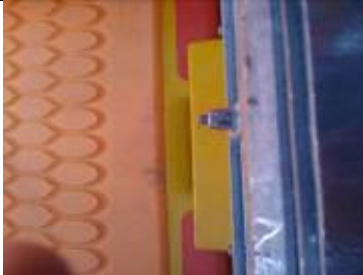
<p data-bbox="1404 485 2136 507">OK if the bolt is behind the motor, but fails if exposed (eg. side of the transom)</p>
Transom Lip (3mm Square)

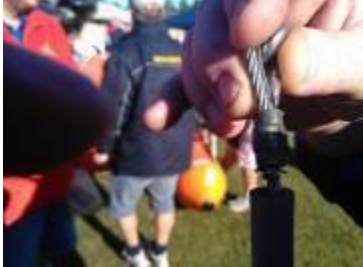
<p data-bbox="1404 1086 1816 1114">Wires are exposed and is a puncture hazard</p>
Eye Bolts		
Bungs (if applicable)

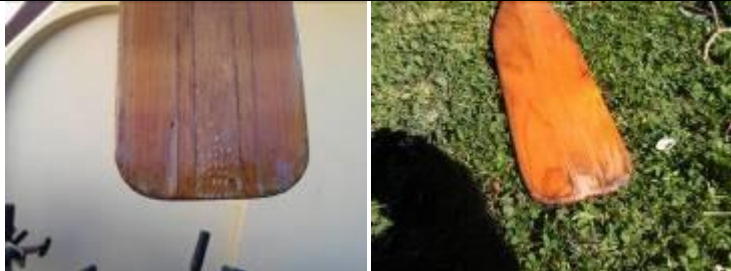
<p>Paddles are split on the end, may fail if required to be used under pressure</p>
15m Tow Rope: Stowage, Splice, Clip & Loop

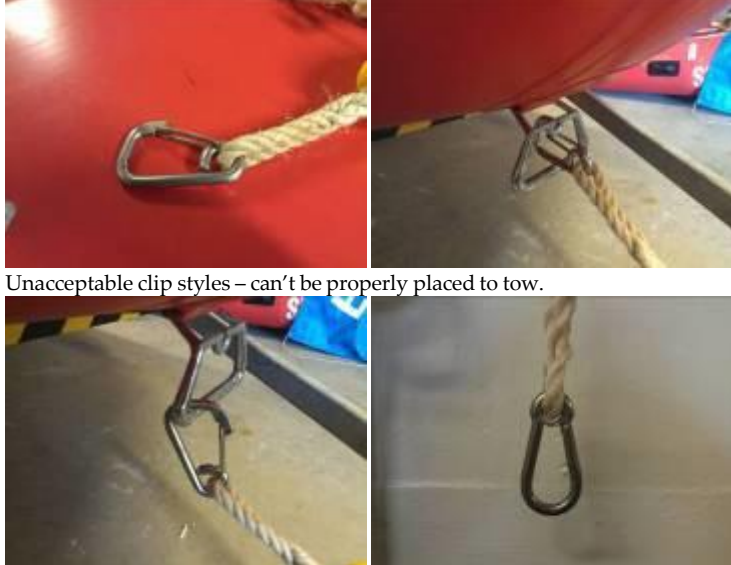
<p>Unacceptable clip styles – can't be properly placed to tow.</p> <p>Incorrect fitting will twist the tow handle: Unacceptable clip – cut hazard</p>
Approved Rescue Tube: Stowage

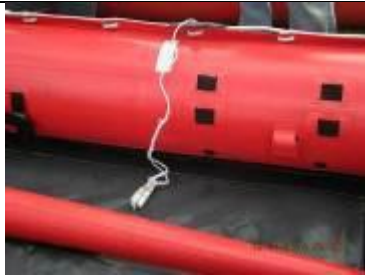
<p>No Velcro straps</p>
Whistle

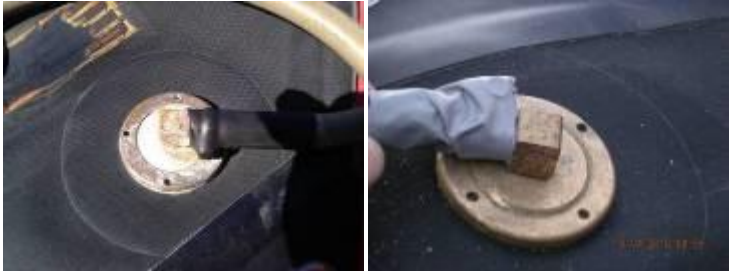
<p>Unacceptable exposed sharp edges: tape has failed to protect cut hazard</p>

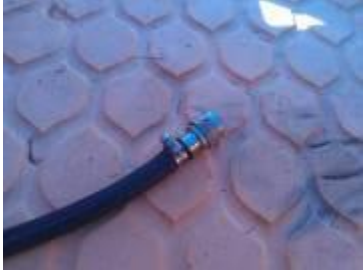
<p>Screw clip is exposed – cut hazard</p>
Floorboards not worn, No holes/sharps

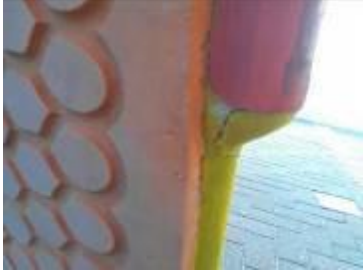
<p>Back of floorboard is cracked and allows water to enter the internal closed cell</p>

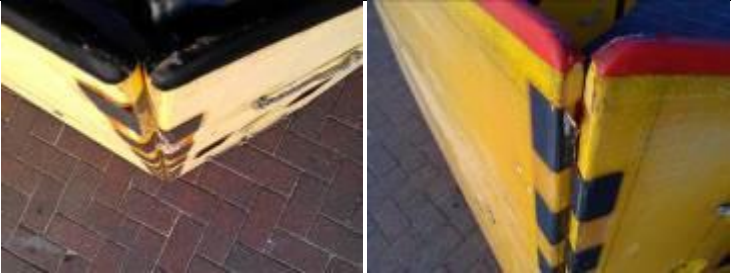
<p>Hinges have failed – once one fails it is likely the rest will also fail</p>
Fuel Tank's Fixings

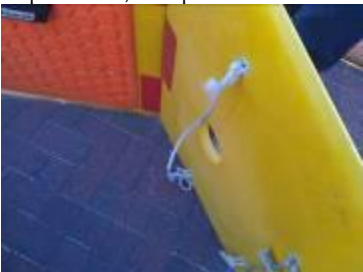
<p>Series of Murrumbidgee Frog knots that will eventually untie and is unreliable</p>

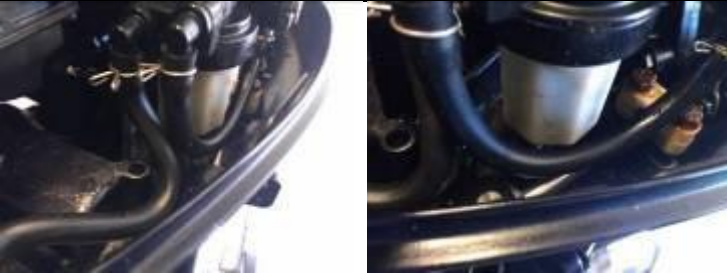
<p data-bbox="1406 1414 2130 1436">Fuel line from filter to pump is too long and is rubbed by the throttle link rod.</p>
