| IRB HULL - INSPECTION CHECKLIST | Acceptable | Unacceptable |

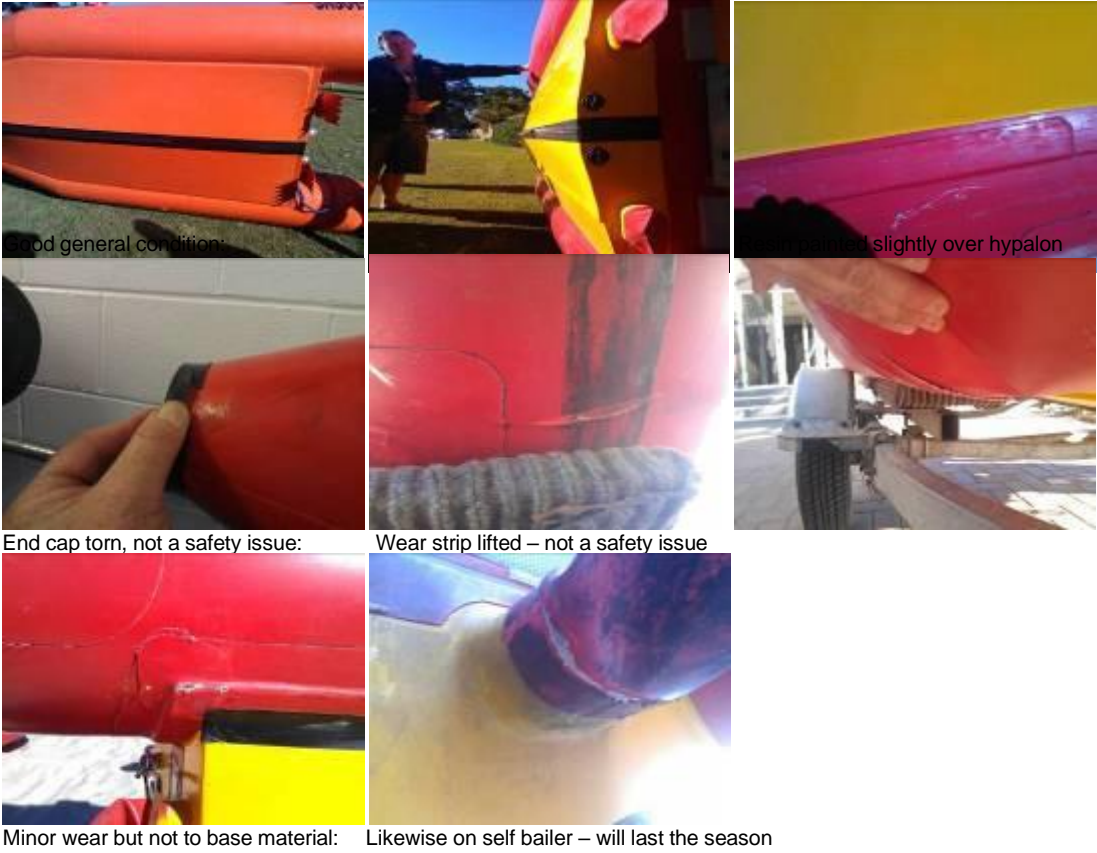
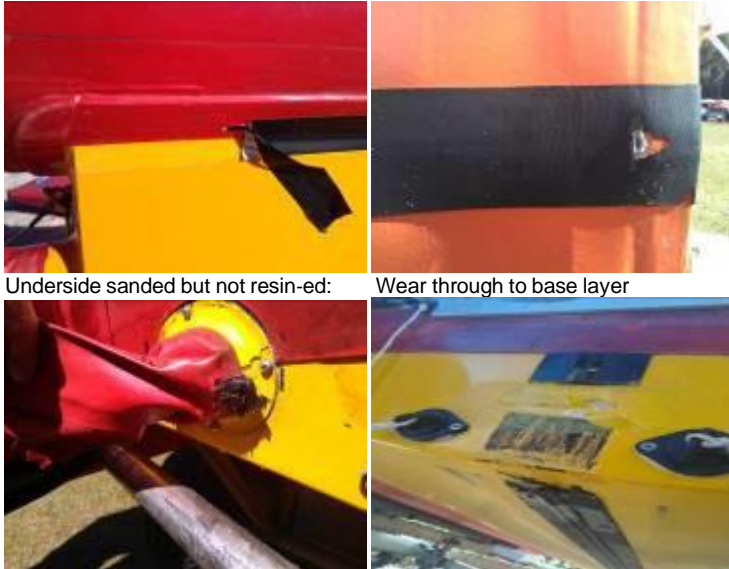
| IRB HULL - INSPECTION CHECKLIST | Acceptable | Unacceptable |
|---|---|---|
| Pontoon Wear to Underside | <p>Good general condition:</p> <p>Slightly sanded slightly over hypalon</p> <p>End cap torn, not a safety issue:</p> <p>Wear strip lifted – not a safety issue</p> <p>Minor wear but not to base material: Likewise on self bailer – will last the season</p> | <p>Underside sanded but not resin-ed: Wear through to base layer</p> <p>Rib self bailer damaged and will let water into hull: Wear strip missing</p> |

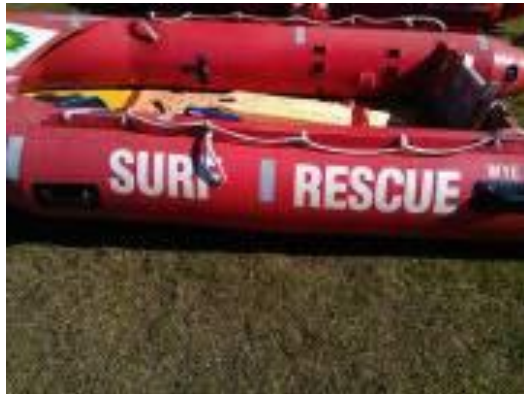
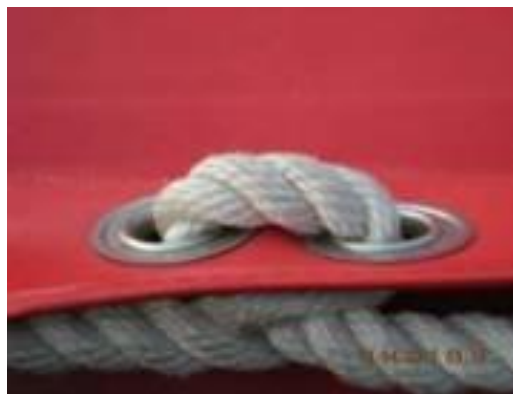
Pontoon
Ropes on
Sides
(Life
lines)

Sufficient slack (but not too much): Eye lets in good condition, not lifted and not sharp or corroded

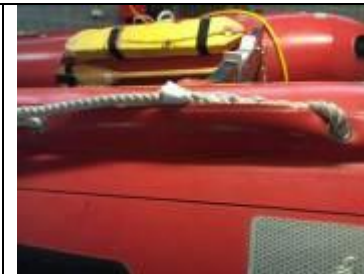
Life line is too tight:

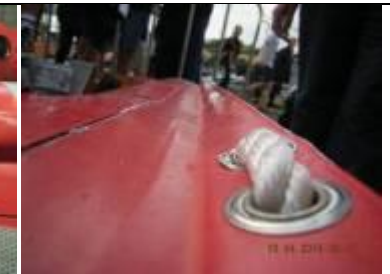
Eyelet has lifted – potential cut hazard

Eyelet is broken – cut hazard (see above and below)

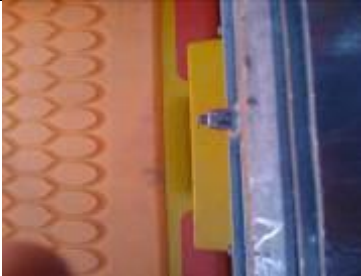
| IRB HULL - INSPECTION CHECKLIST | Acceptable | Unacceptable |
|--|---|---|
| Transom Plate Wear (1mm) + bolts flush | <p data-bbox="1003 469 1285 491">Bolts are cut flush with the nut</p> | <p data-bbox="1406 481 2132 504">OK if the bolt is behind the motor, but fails if exposed (eg. side of the transom)</p> |

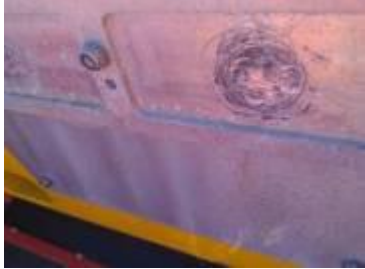
| IRB HULL - INSPECTION CHECKLIST | Acceptable | Unacceptable |
|--|---|---|
| Transom Lip (3mm Square) | <p data-bbox="273 785 604 807">Good 3mm lip and no sharp edges.</p> | |

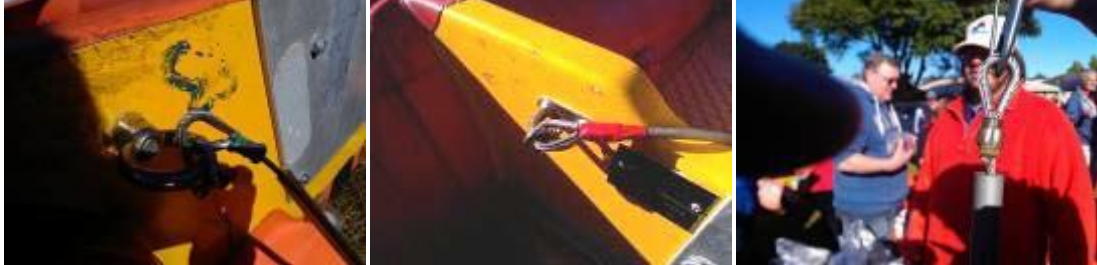
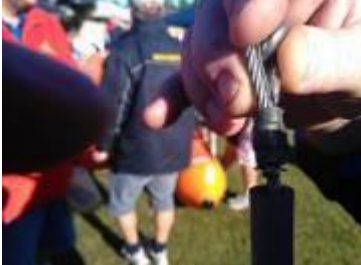
| IRB HULL - INSPECTION CHECKLIST | Acceptable | Unacceptable |
|--|---|---|
| Motor Safety Cable (1/boat) | <p data-bbox="273 1088 1285 1110">Crimp has belled but still structural and no sharp wires: Tape any sharp wires: Wires too short to cause injury</p> | <p data-bbox="1406 1088 1823 1110">Wires are exposed and is a puncture hazard</p> |

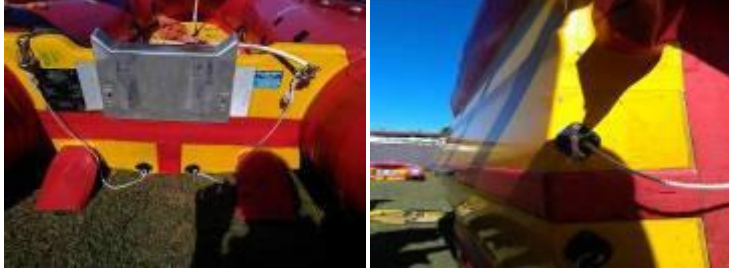
| IRB HULL - INSPECTION CHECKLIST | Acceptable | Unacceptable |
|--|---|---|
| Bungs (if applicable) | <p data-bbox="273 1433 797 1455">Safety cords for the bungs (shorter bungy style is better)</p> | |

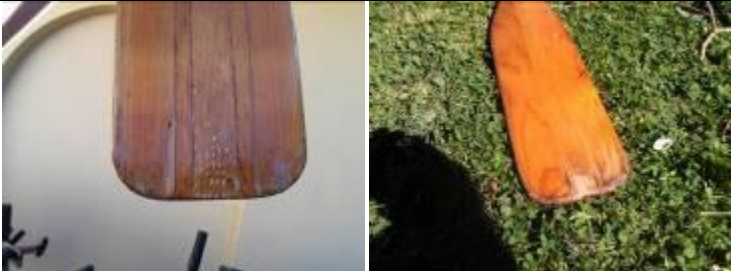
| IRB HULL - INSPECTION CHECKLIST | Acceptable | Unacceptable |
|---|--|--|
| Paddles: Stowage, Condition + Correct Size (1 set/boat) | | <p>Paddles are split on the end, may fail if required to be used under pressure</p> |

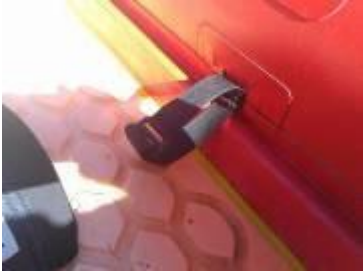
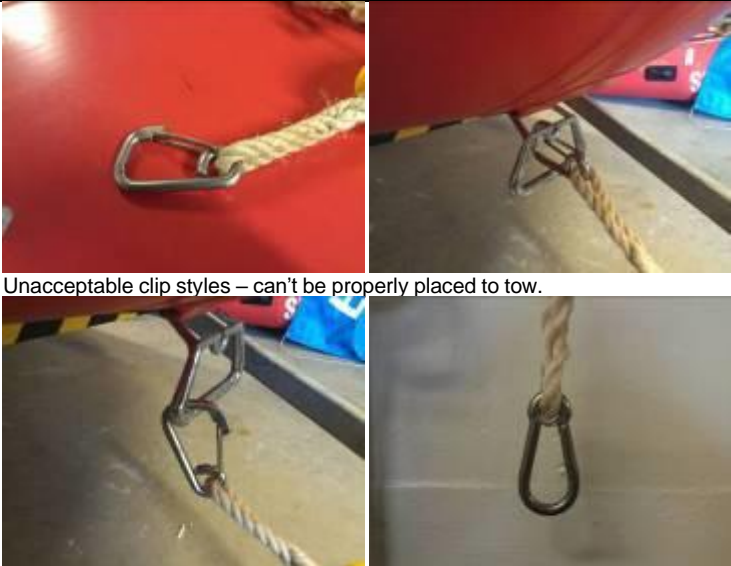
| IRB HULL - INSPECTION CHECKLIST | Acceptable | Unacceptable |
|---|--|--|
| 15m Tow Rope: Stowage, Splice, Clip & Loop | <p>Velcro overlock system or similar is acceptable</p> | <p>Unacceptable clip styles – can't be properly placed to tow.</p> <p>Incorrect fitting will twist the tow handle: Unacceptable clip – cut hazard</p> |

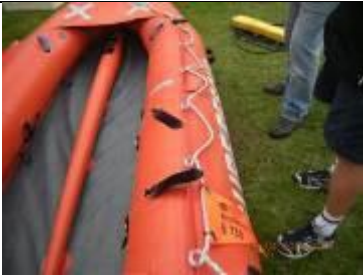
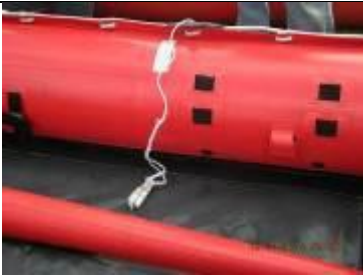
| IRB HULL - INSPECTION CHECKLIST | Acceptable | Unacceptable |
|---|--|--|
| Approved Rescue Tube: Stowage | <p>Velcro straps fitted</p> | <p>No Velcro straps</p> |

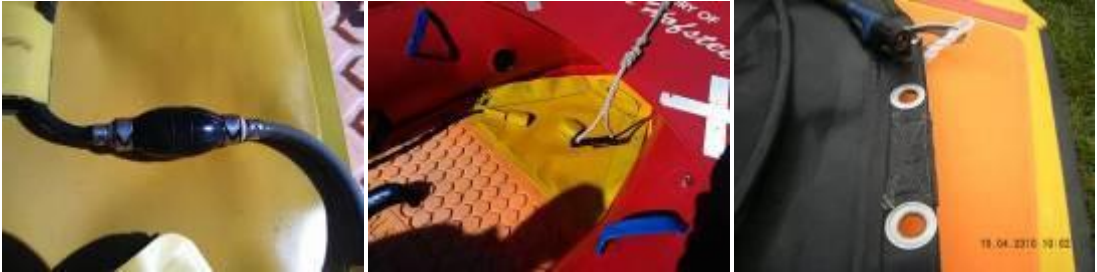
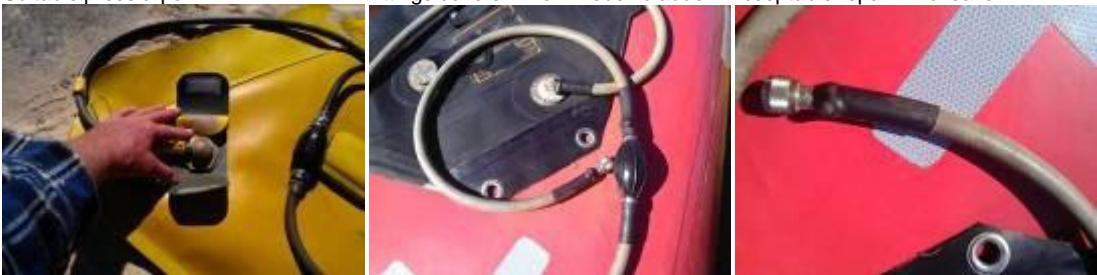
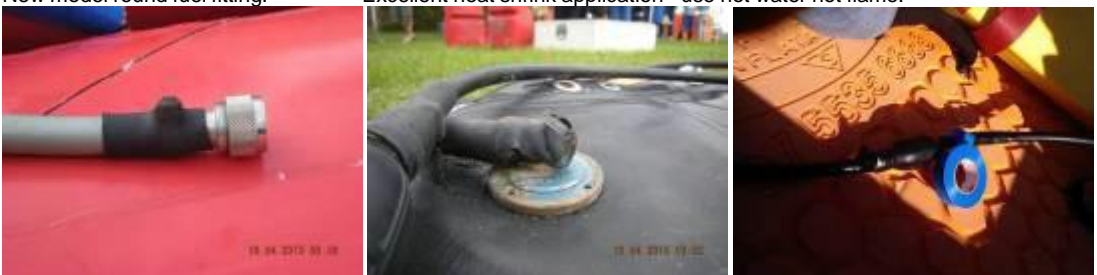
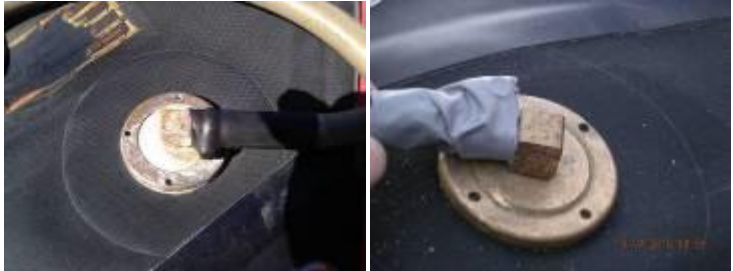
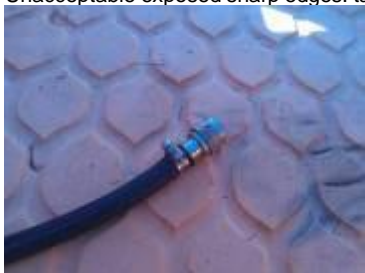
| IRB HULL - INSPECTION CHECKLIST | Acceptable | Unacceptable |
|---|--|--|
| Fuel Tank (no leaks, no sharps) | <p>Suitable press clips: Fittings covers in new model bladder: Acceptable repair – no leaks</p> <p>New model round fuel fitting: Excellent heat shrink application - use hot water not flame:</p> <p>Heat shrink covers the zip tie: Self amalgamating tape protects sharp edges: Insulation tape as a last resort</p> | <p>Unacceptable exposed sharp edges: tape has failed to protect cut hazard</p> <p>Screw clip is exposed – cut hazard</p> |

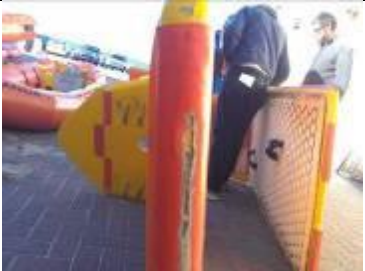
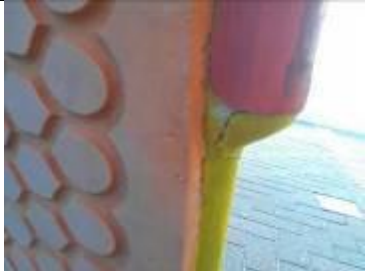
| IRB HULL - INSPECTION CHECKLIST | Acceptable | Unacceptable |
|---|--|--|
| Floorboards not worn, No holes/sharps | <p>Not worn to base material or fiberglass – expected to last the season and not a safety hazard</p> | <p>Back of floorboard is cracked and allows water to enter the internal closed cell</p> |

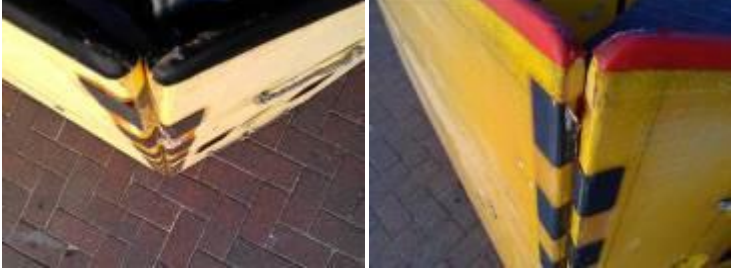
| IRB HULL - INSPECTION CHECKLIST | Acceptable | Unacceptable |
|--|--|---|
| Floorboard hinge condition (if applicable) | | <p>Hinges have failed – once one fails it is likely the rest will also fail</p> |

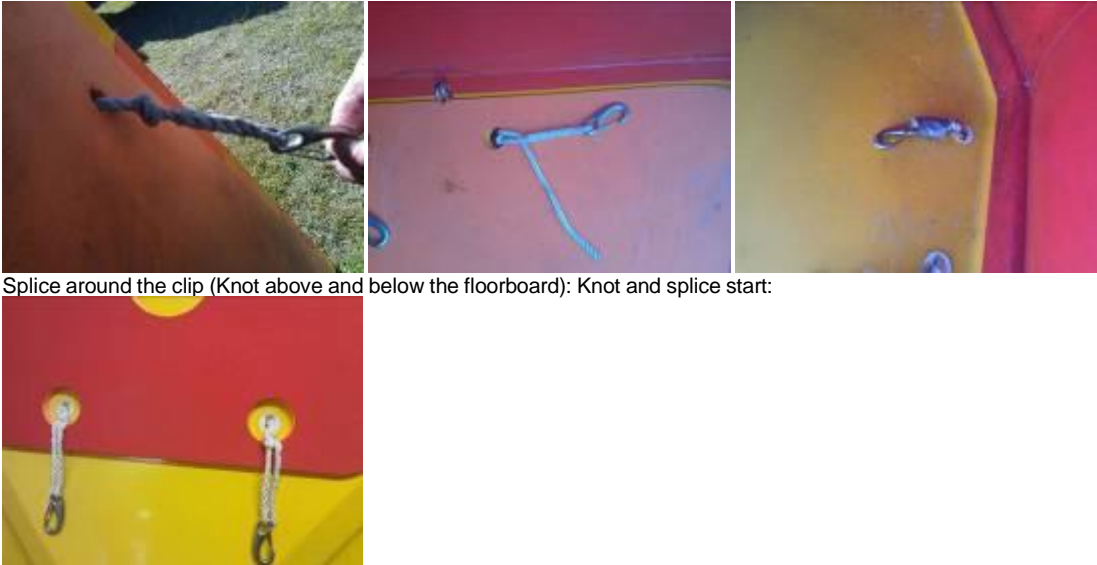
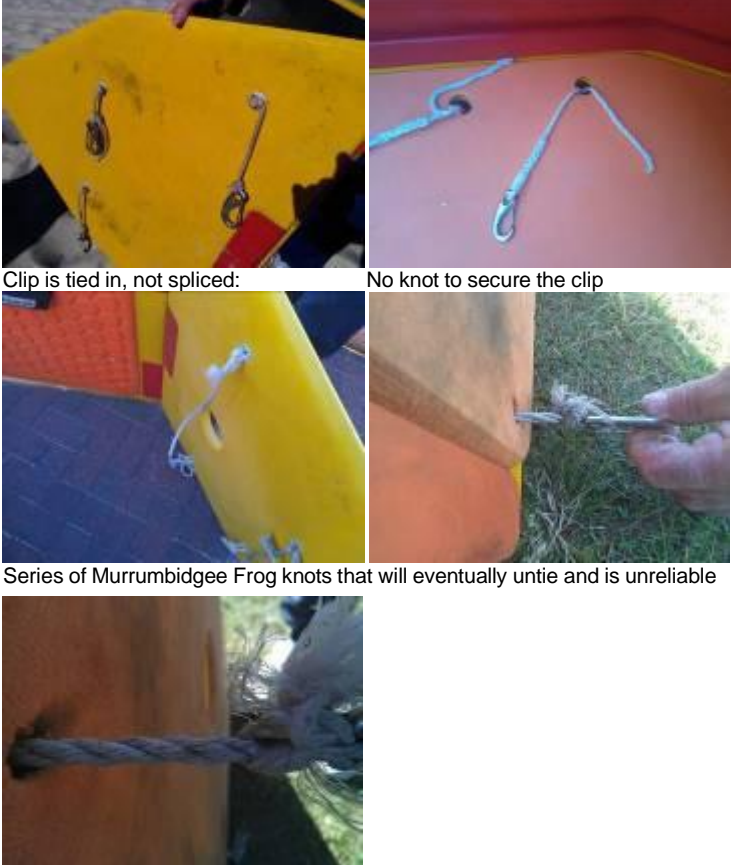
| IRB HULL - INSPECTION CHECKLIST | Acceptable | Unacceptable |
|--|--|---|
| Fuel Tank's Fixings | <p>Splice around the clip (Knot above and below the floorboard): Knot and splice start:</p> <p>Knot on the running side of the floor plug (Clip, plug then knot)</p> | <p>Clip is tied in, not spliced: No knot to secure the clip</p> <p>Series of Murrumbidgee Frog knots that will eventually untie and is unreliable</p> |

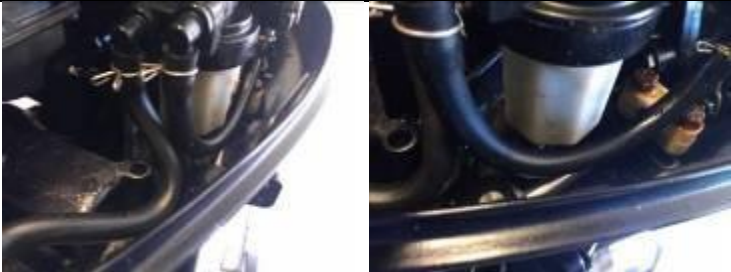
| IRB MOTOR - INSPECTION CHECKLIST | Acceptable | Unacceptable |
|--|--|--|
| Condition of hoses and wiring | | <p data-bbox="1406 1412 2134 1436">Fuel line from filter to pump is too long and is rubbed by the throttle link rod.</p> |

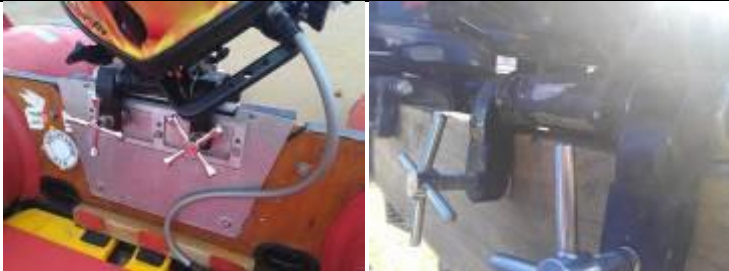
| Clamp Threads and Handles | <p data-bbox="286 352 801 375">Showing both type of acceptable spinner clamp screws</p> | |

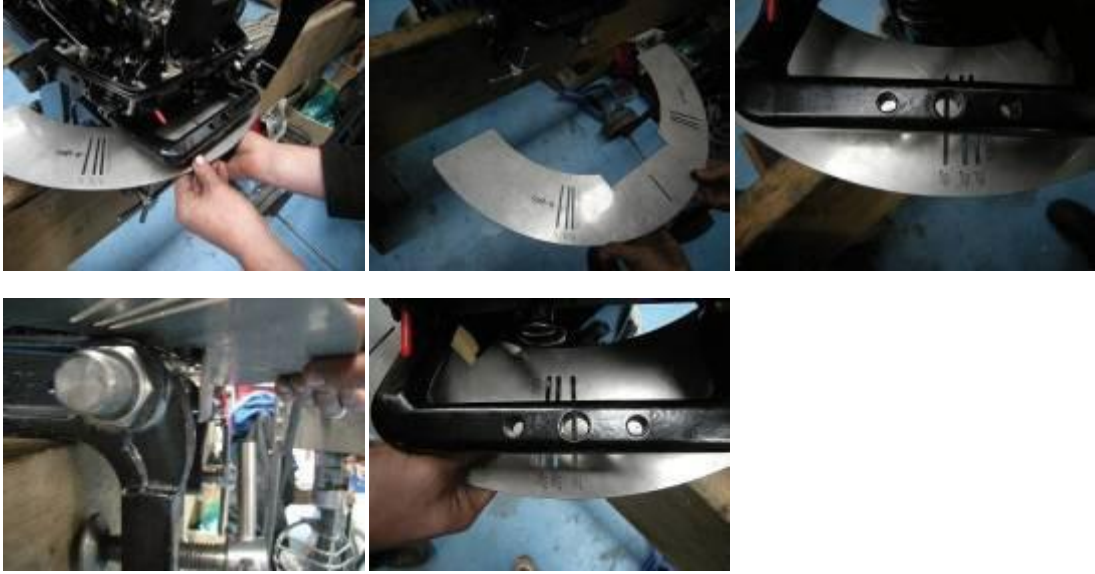
| <p>Swivel Bracket Lugs remain and Steering Pin Tab removed, but only to 45 degr.</p> | | |
