Sydney Branch Gear Inspection procedure for IRB motors
Tohatsu 25hp steering tube and tilt tolerance

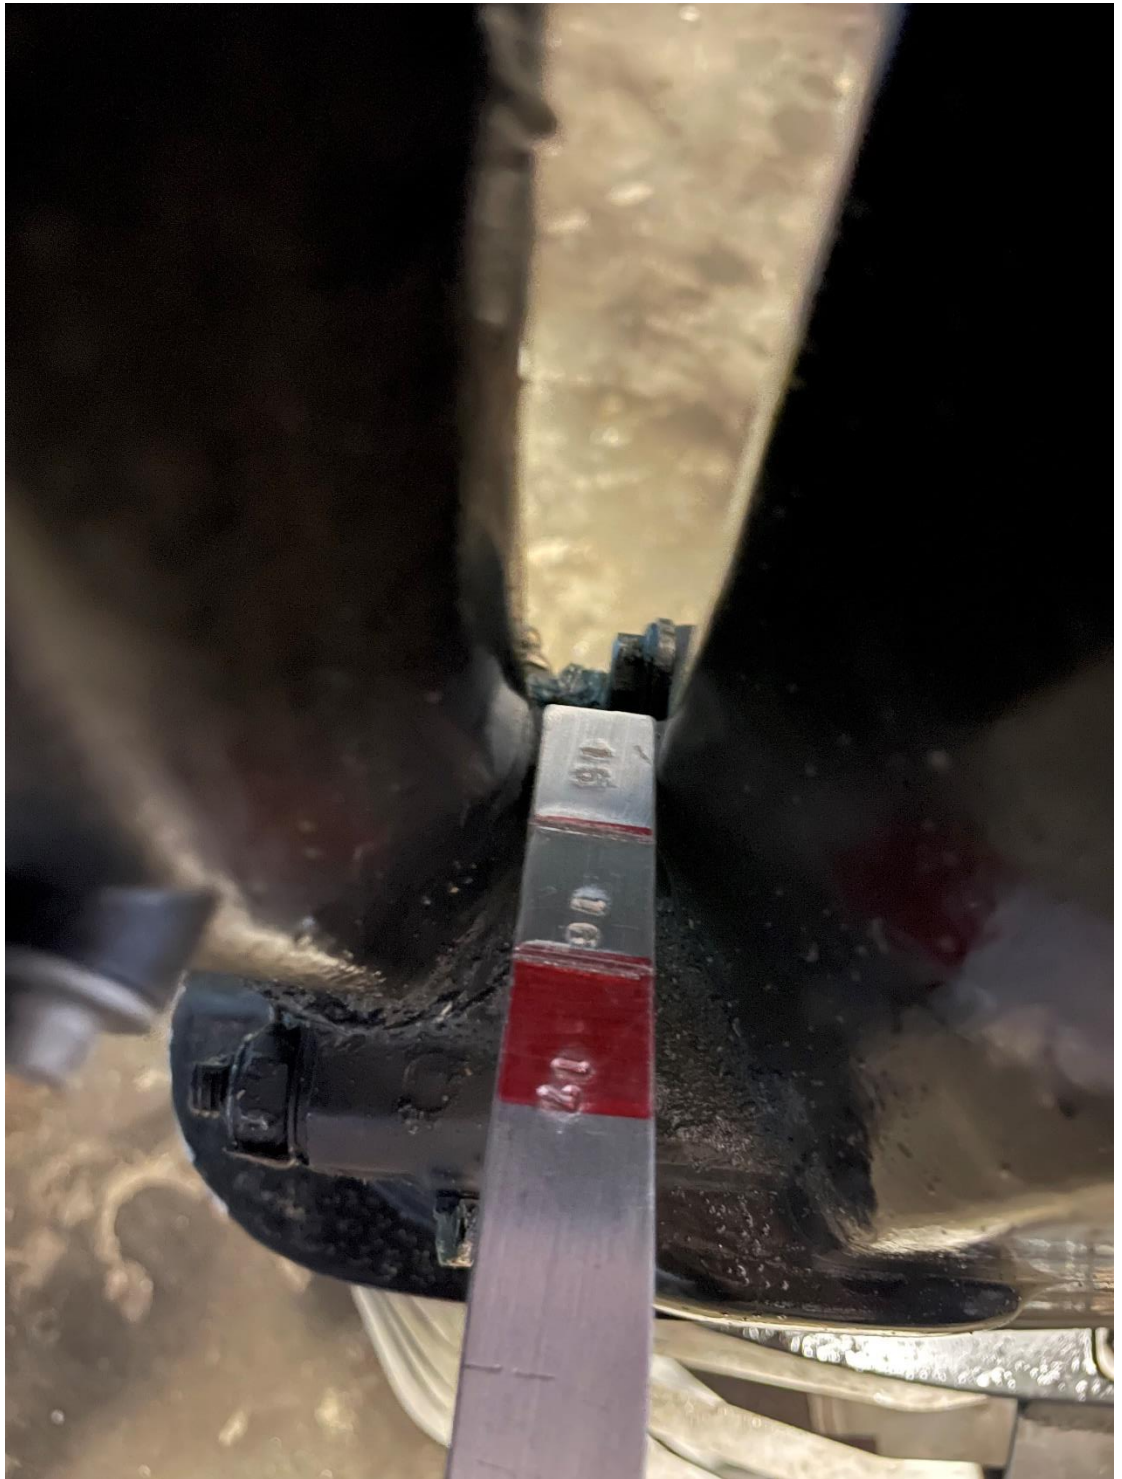
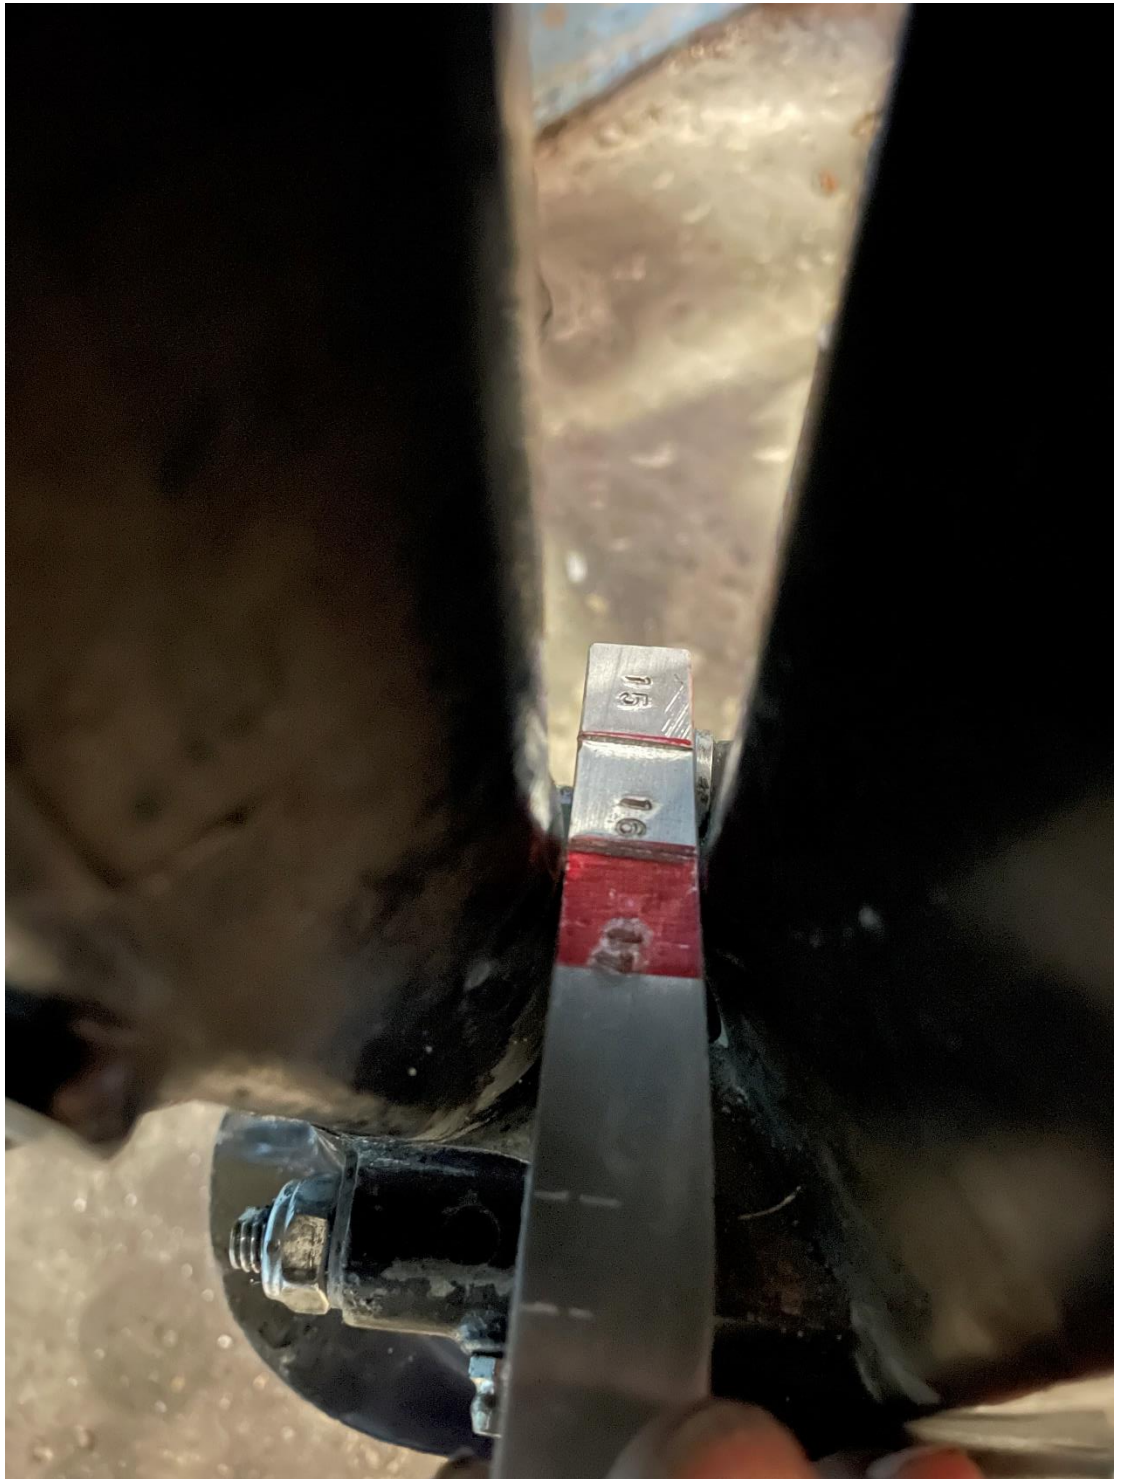
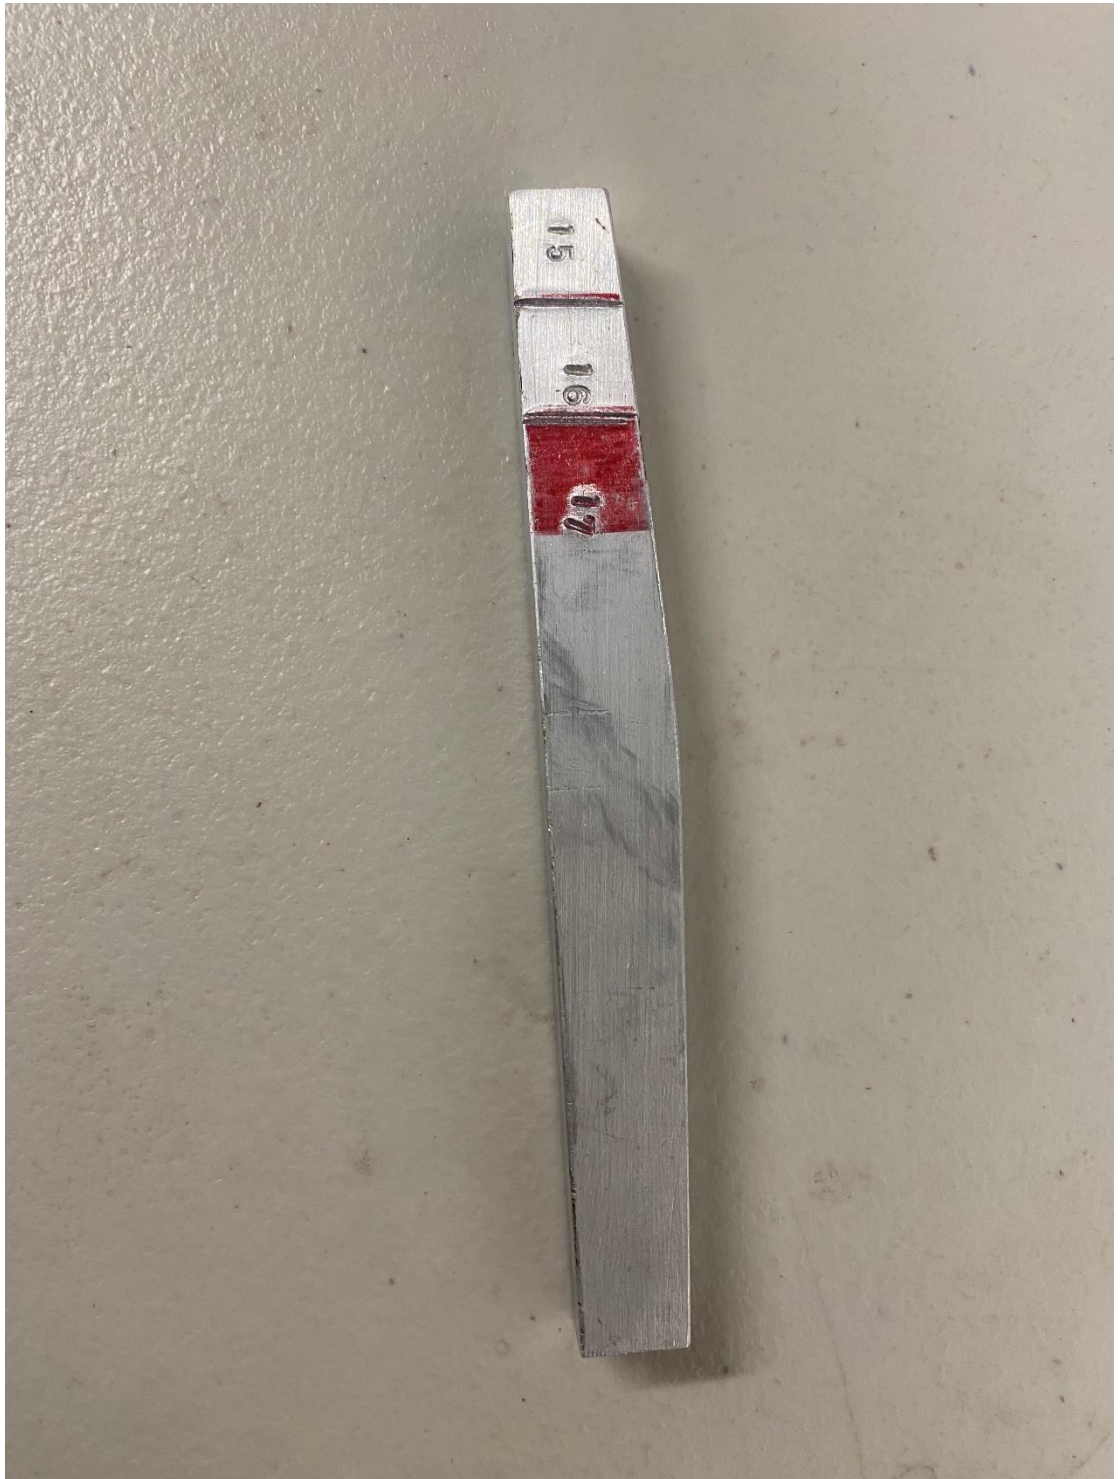
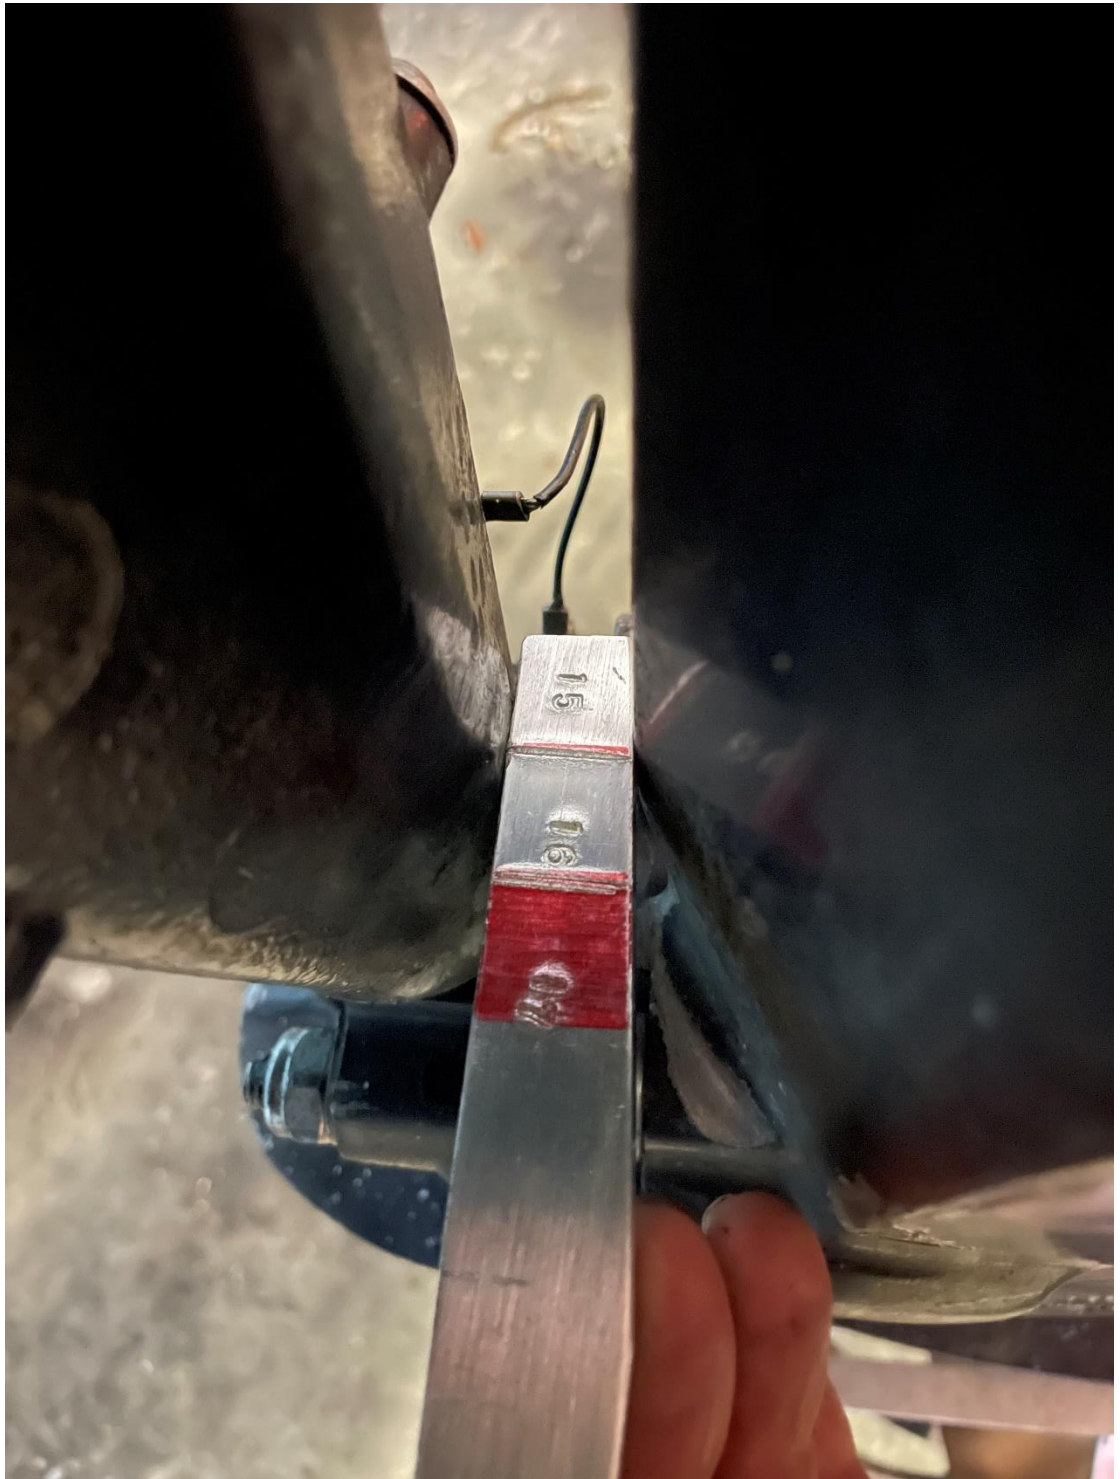
3. Ensure the motor is clamped and held securely, and keep the rope parallel to and directly beneath the propeller shaft.
4. **Insert taper gauge between steering bracket and exhaust leg. Record clearance. Remove gauge. See attached photos**

1. The rope/ cord or cable used shall be no longer than 400mm and with no elasticity.
2. It will be hooked to the bottom of the propeller guard and attached to a portable (luggage/ fish) type scale at the other end.

7. Continue until the motor has moved between 50mm and 150mm and the scale has registered a maximum reading.
8. Repeat steps **4 to 6** of the test a minimum of 3 times to get reliable readings.

9. Readings greater than 15kg indicate that the bushings inside the **tilt** assembly are likely fit for service.
10. **Readings calculated from step 4 and 6 indicate steering bushes have reached their operational limits and will require replacement.**
